Hull Springs Farm: Lower Machodoc Creek, Westmoreland County, Virginia

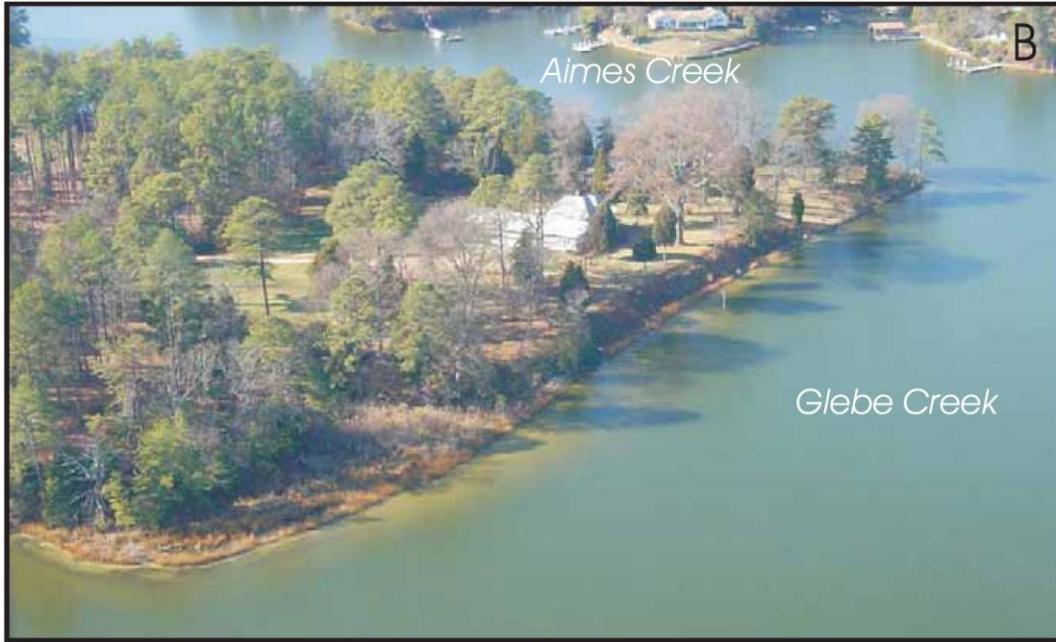
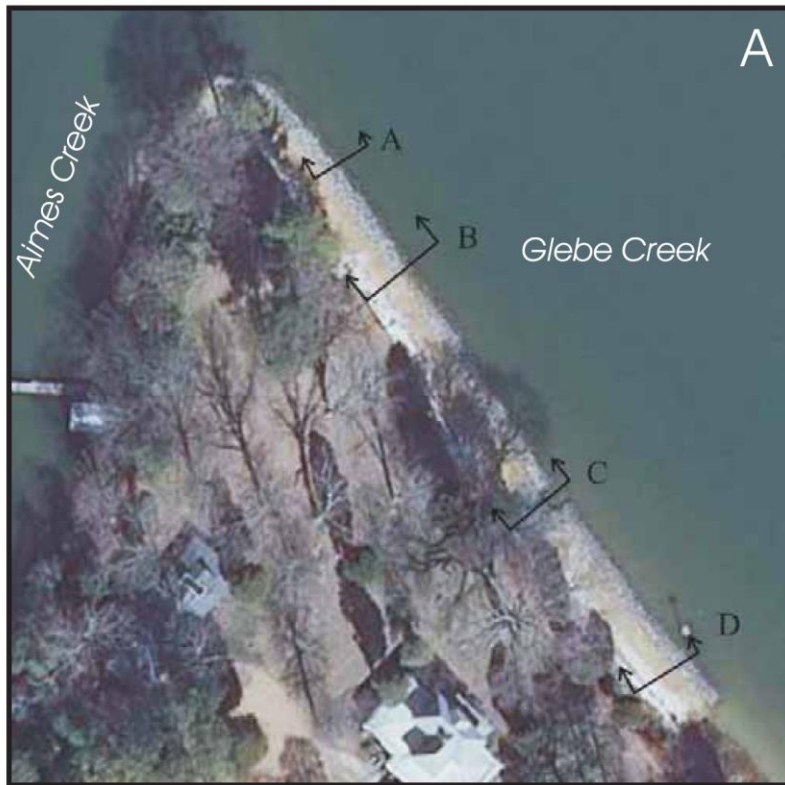
Hull Springs Farm was obtained by Longwood University in 2000 to serve as a research venue for various subjects including shoreline processes, habitat, and management. Longwood obtained a grant from NOAA in 2005 to develop a GIS-based shoreline management plan for Lower Machodoc Creek including the approximately two miles of tidal shoreline around Hull Springs Farm. Most of the shoreline at Hull Springs Farm has small fetches and sheltered coasts, except for the shoreline in front of the “Manor House” which was actively eroding (**Figure 1**).

Figure 1 Longwood University's Hull Springs Farm on Glebe Creek. A) Before the shoreline project, the bank is eroding in front of the Manor House. B) After the project, the shore zone was widened with sand behind the sills.

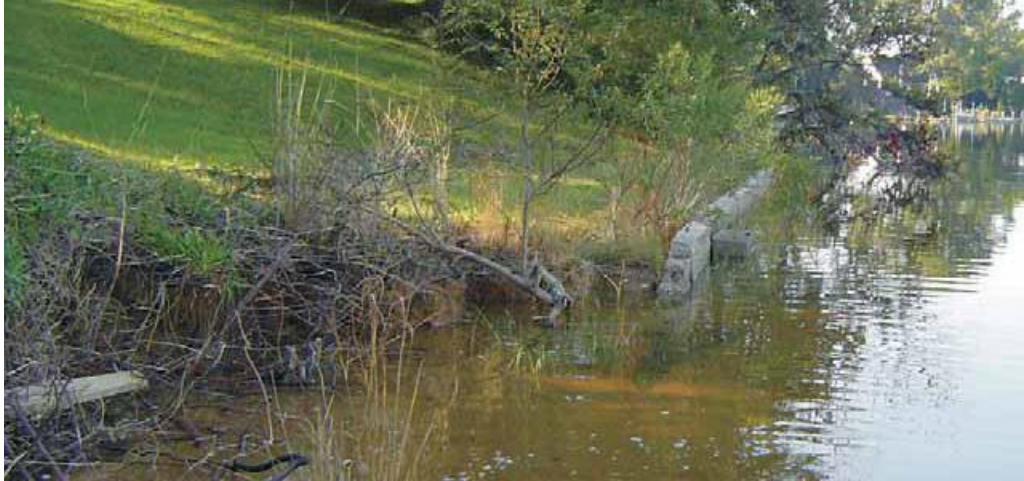
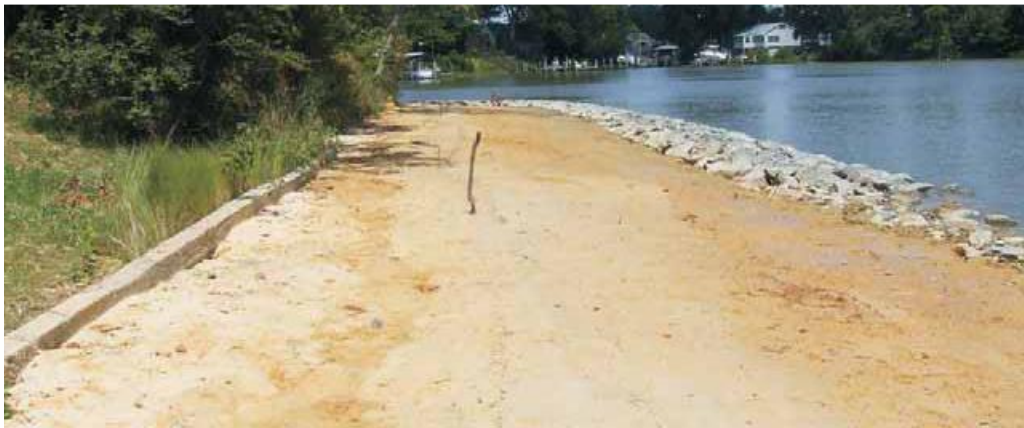
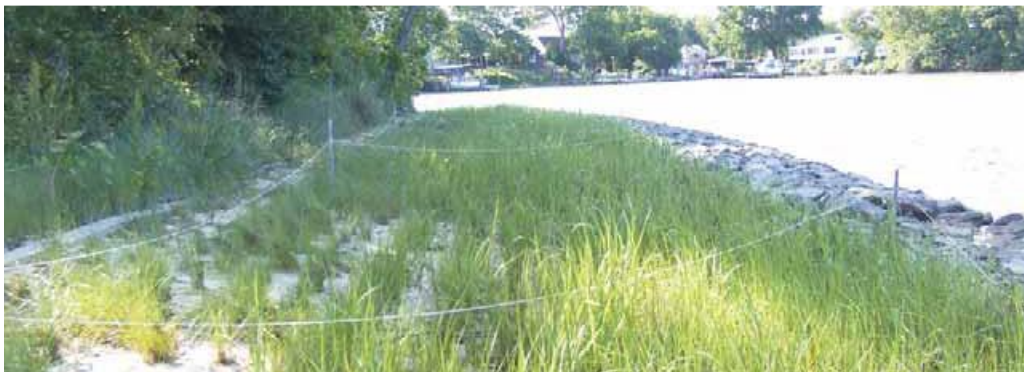
The shoreline occurs as a high upland bank composed of basal clay overlain by some very sandy strata. The base of the bank is generally erosive along the project site while the bank face is erosive to transitional to stable (**Figure 2**).

Figure 2. Hull Springs Farm shoreline. (Top) before construction, (middle) after construction of the sill and placement of sand and (bottom) after planting.

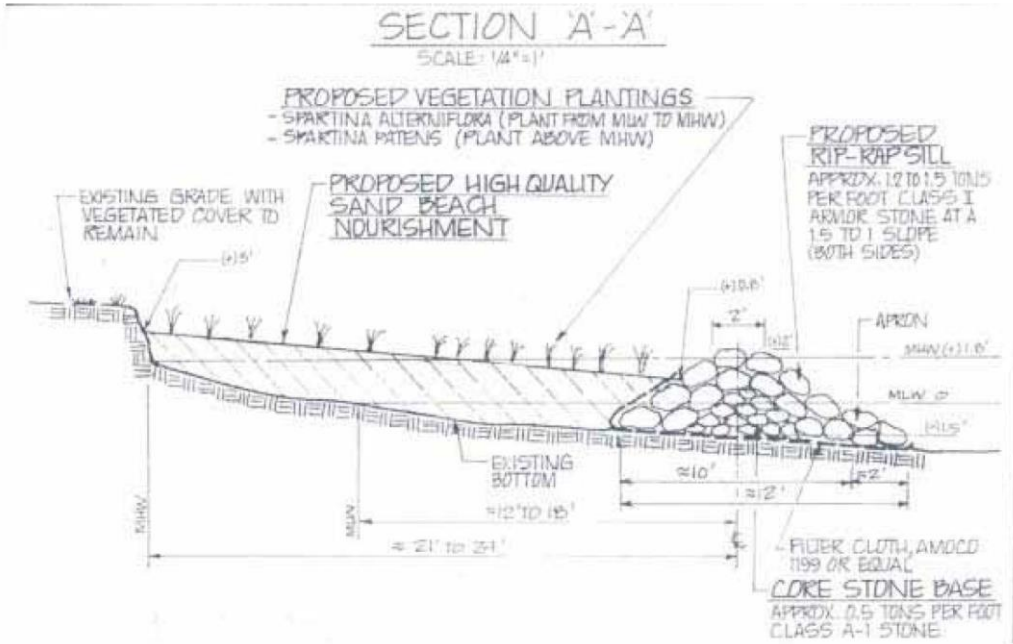
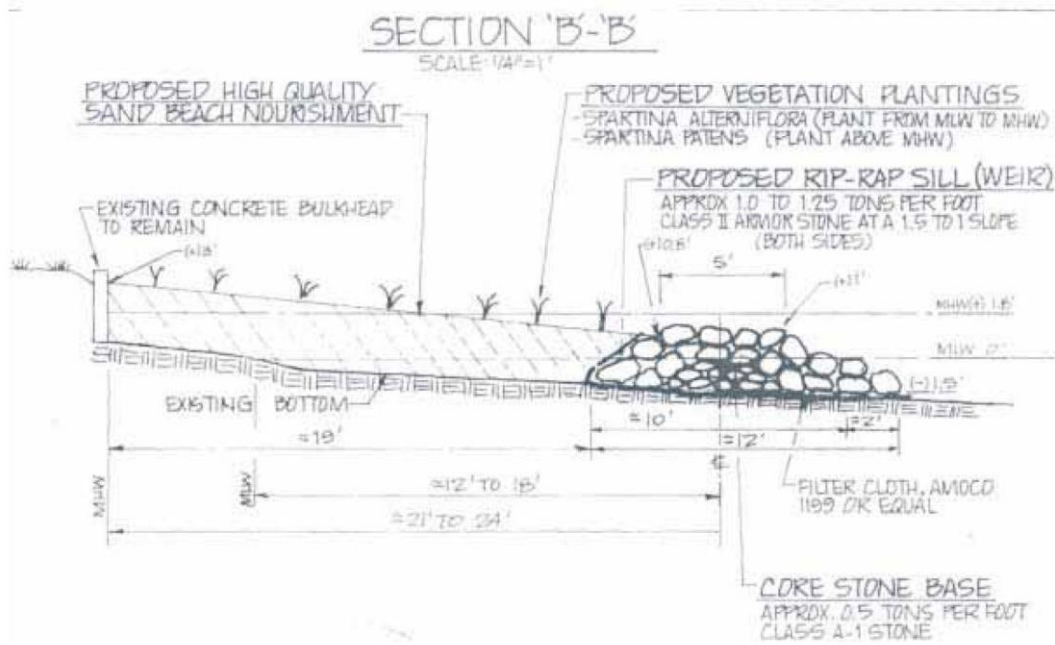
Figure 3. Typical cross-sections for sill built at Hull Springs Farm. Section locations are shown on Figure 1. Permit drawings by Bayshore Design, LLC.

The sand fill begins at +3 on the bank and old bulkhead and extends on a 10:1 slope to about mid-tide (+0.8) at the back of the sill (A-A, **Figure 3**). This provides planting widths of about 10 ft for *Spartina alterniflora* and 12 ft for *Spartina patens*.

The revetment was set at +6 ft MLW, the approximate top of scarp resulting from Ernesto. The sill, as originally planned, began at the northernmost end of the neck and extended southward across the upland bank area of active erosion. A low weir section was designed in the sill at the bulkhead (B-B, **Figure 3**) and an open window was designed in front of the revetment. In order to keep the window open, a cobble pavement was proposed instead of sand (C-C, **Figure 4**). Less sand fill was needed toward the south end of the project and only as an amendment to the existing marsh fringe. The revetment was built first, then the sill system. The revetment was built along about 400 ft of shoreline in front of the large oak tree.

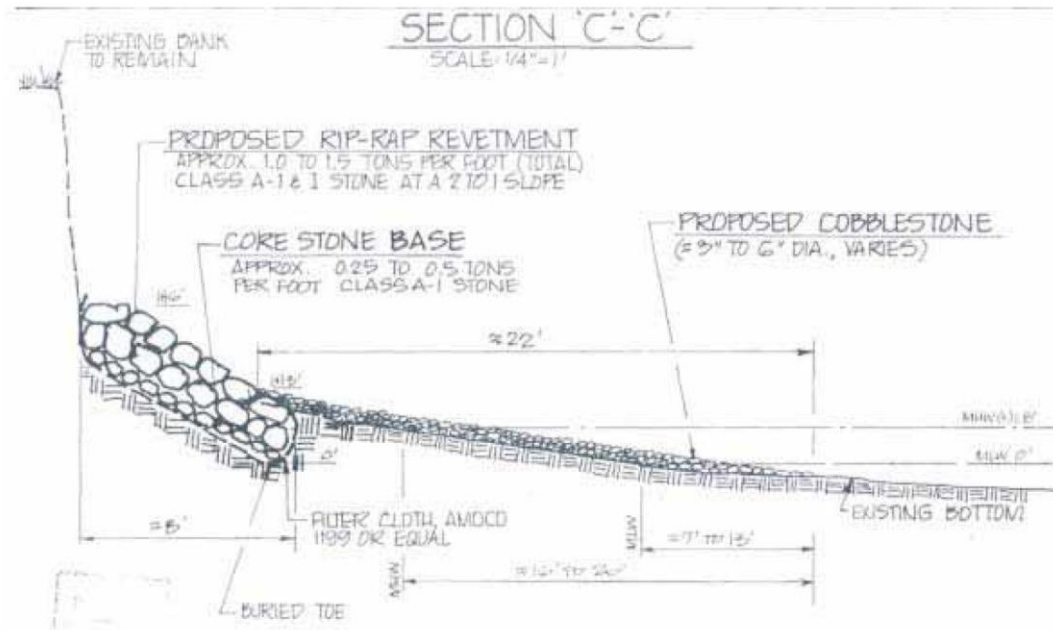
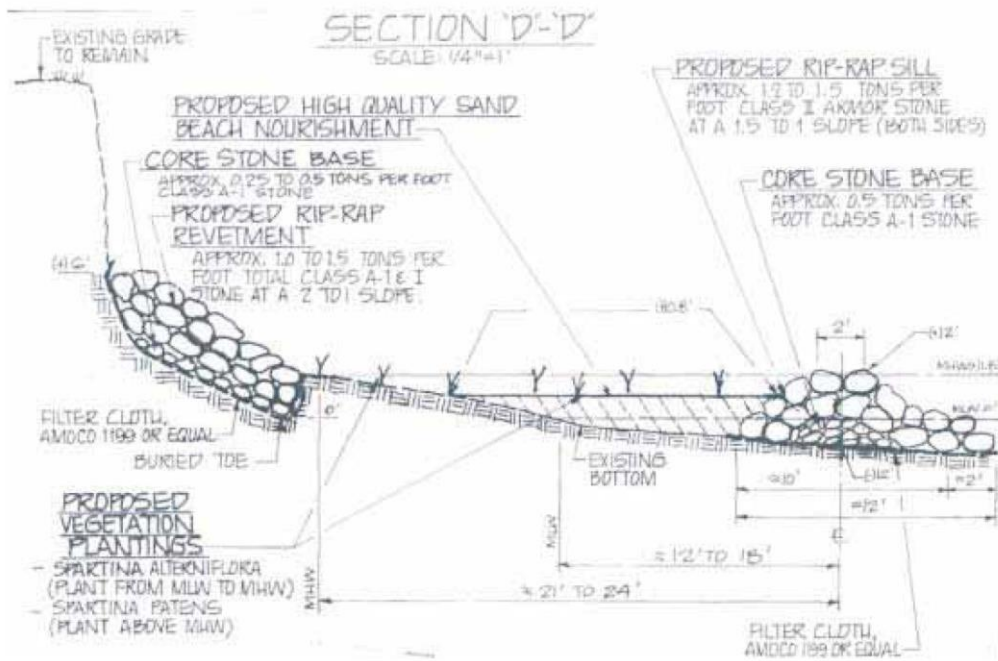
Due to Tropical Storm Ernesto in 2006, the base of bank was significantly impacted, and the nature of the long-term erosion was dramatically revealed. The wave cut bank scarp from the storm was 6 ft high and eroded one to 2 ft in some areas. It was evident that the proposed sill was not sufficient for immediate protection of the base of bank since continued erosion would threaten the old oak tree on top of the bank. The design was modified to include a stone revetment in the vicinity of and adjacent to the old oak. The sill was still built in front (waterside) of the revetment (**Figure 4**).

Figure 4. Typical cross-sections for sill built at Hull Springs Farm. Section locations are shown on Figure 1. Permit drawings by Bayshore Design, LLC.
