Failed Structures

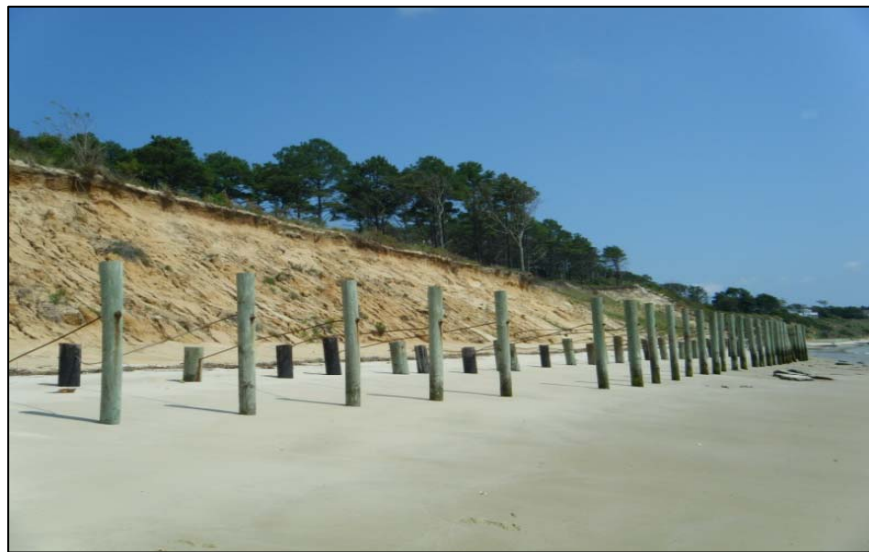
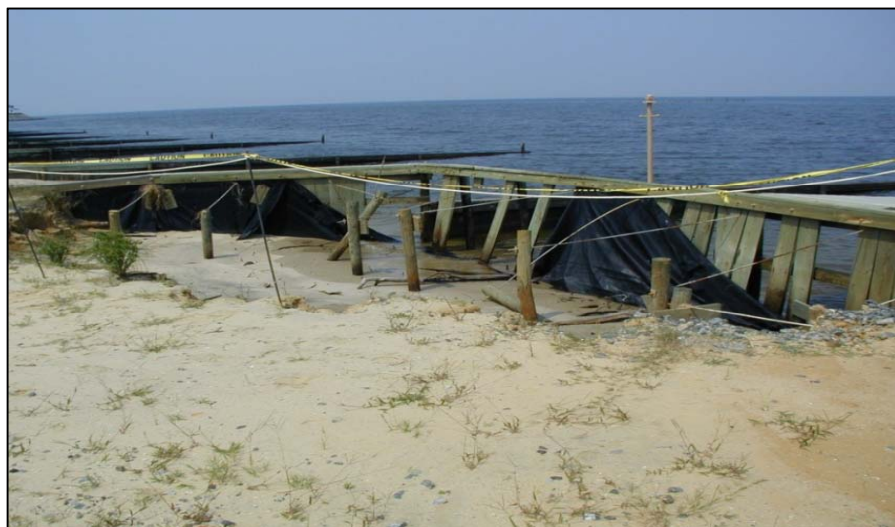
Failed Bulkheads

missing sheeting, damaged tieback systems, complete loss of backfill material, erosion and tidal inundation are now occurring behind the entire structure.

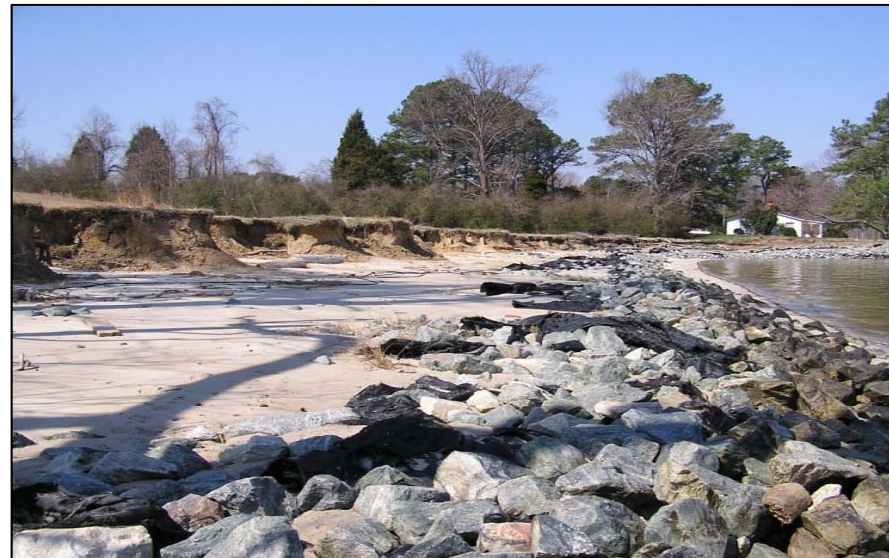
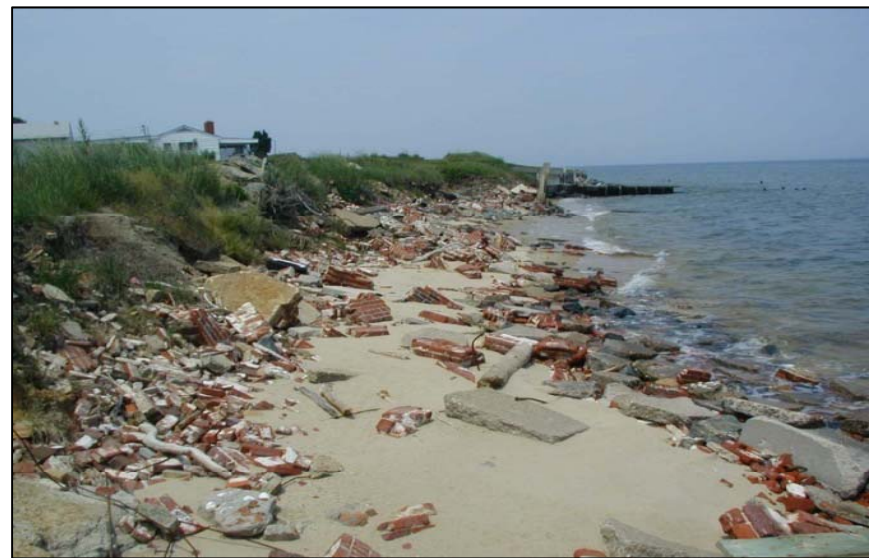
Failed Revetments

material scattered beyond original footprint, major erosion still occurring, no longer provide wave attenuation

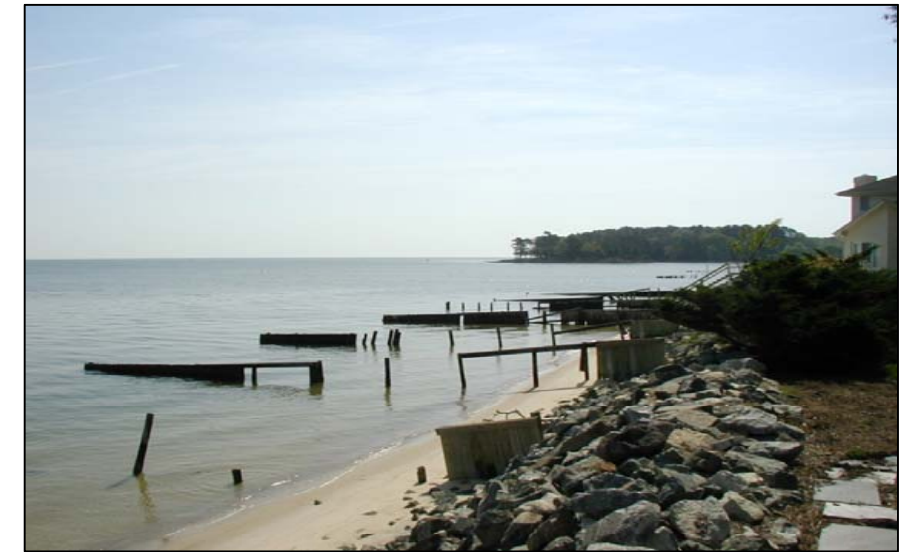
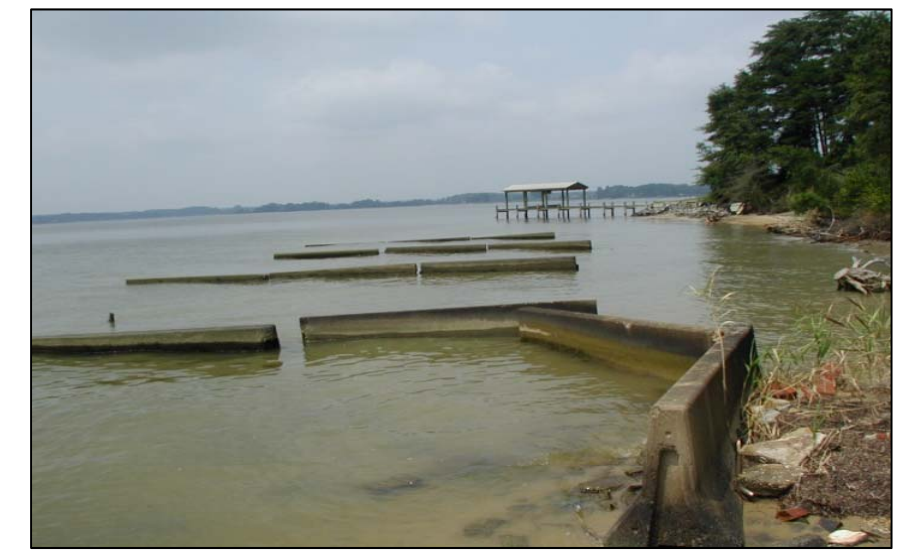
Failed Groins

with separated sections and missing parts, highly permeable, cannot trap sand anymore, not connected to upland

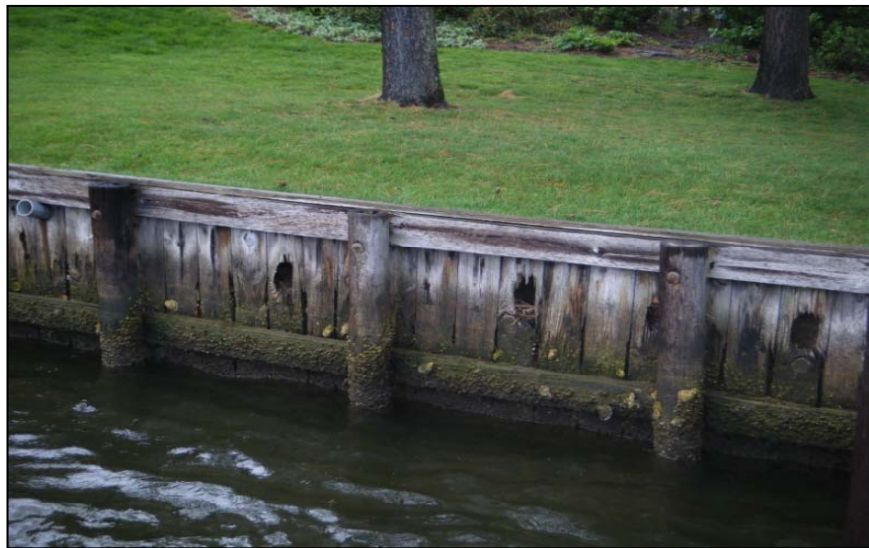
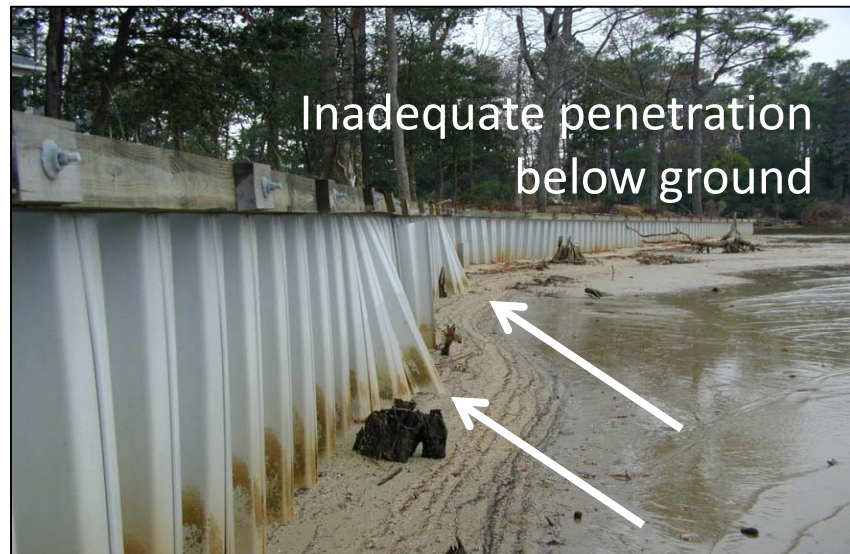
Failing or Flanked Bulkheads

loss of backfill (sinkholes) along top of bulkhead; bowed or leaning sections; rotting timber and/or pilings; missing sheetpiles; erosion is visible behind, above or around end(s) of bulkhead

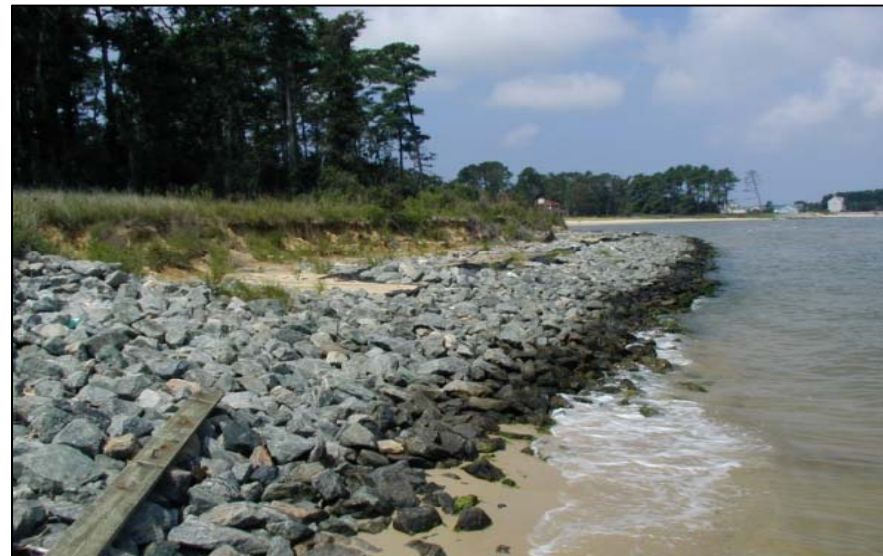
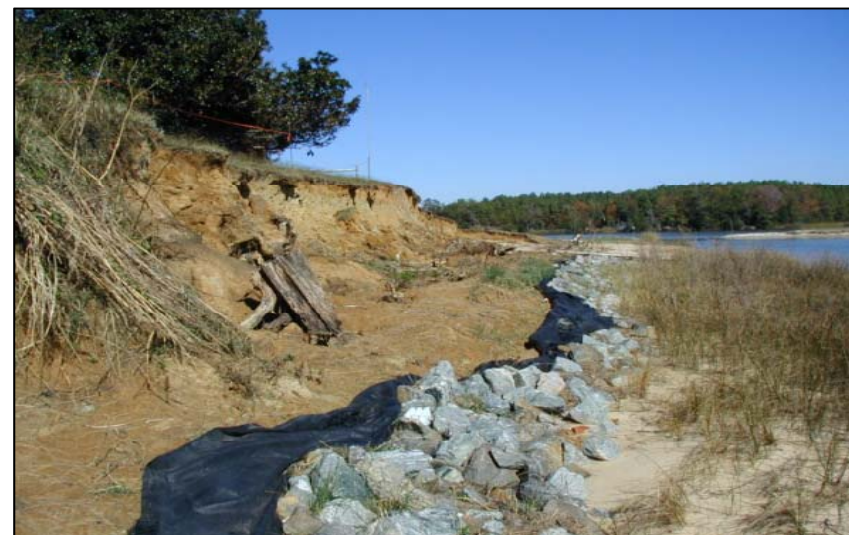
Failing or Flanked Revetments

slope is flattened, stone is scattered either at toe or above structure, stone is collapsing onto shoreline; erosion is visible behind, above or around end(s) of structure

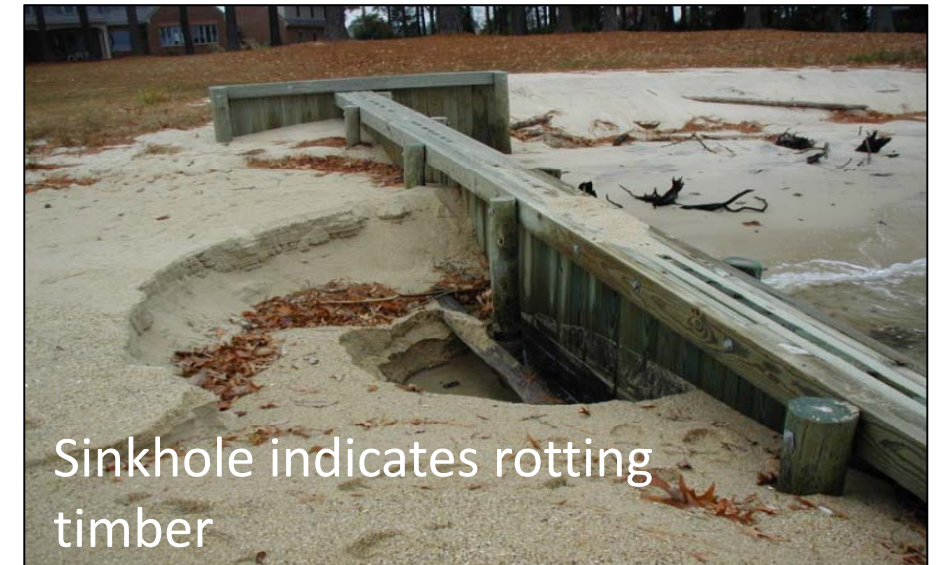
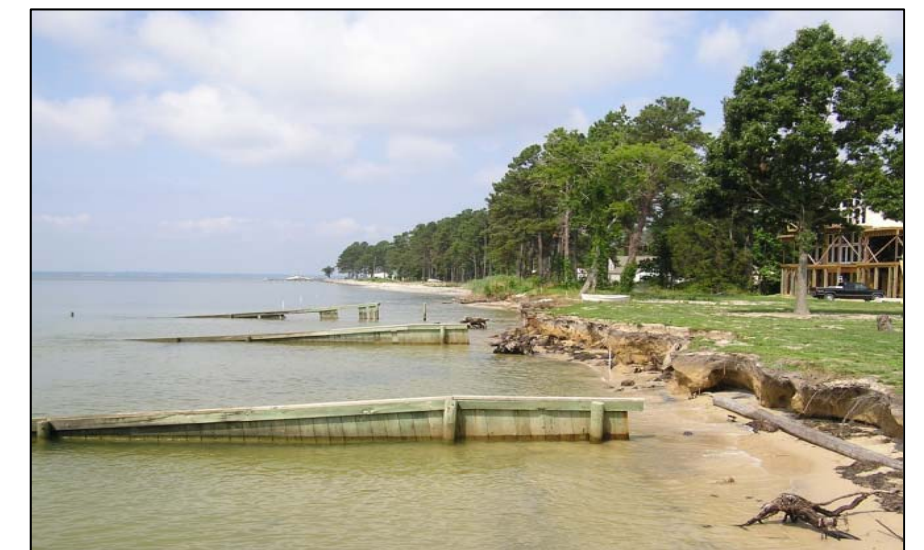
Failing or Flanked Groins

rotting timber or pilings, loss of beach sand (sinkholes) next to groin; bank erosion landward from groins
