Failed Structures

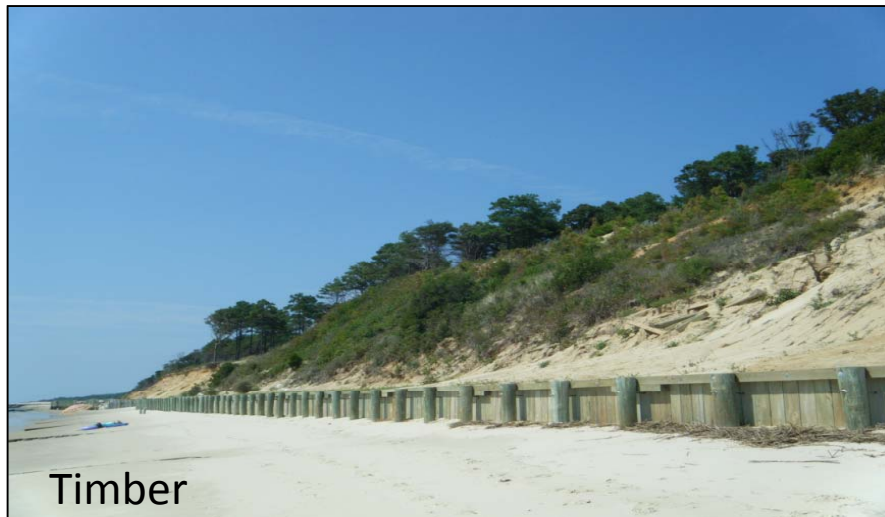
Timber

retaining upland bank soil with no apparent structural problems; no erosion above, along toe (at shoreline level), or at the ends of bulkhead. Typically constructed with timber or vinyl sheeting with galvanized hardware.

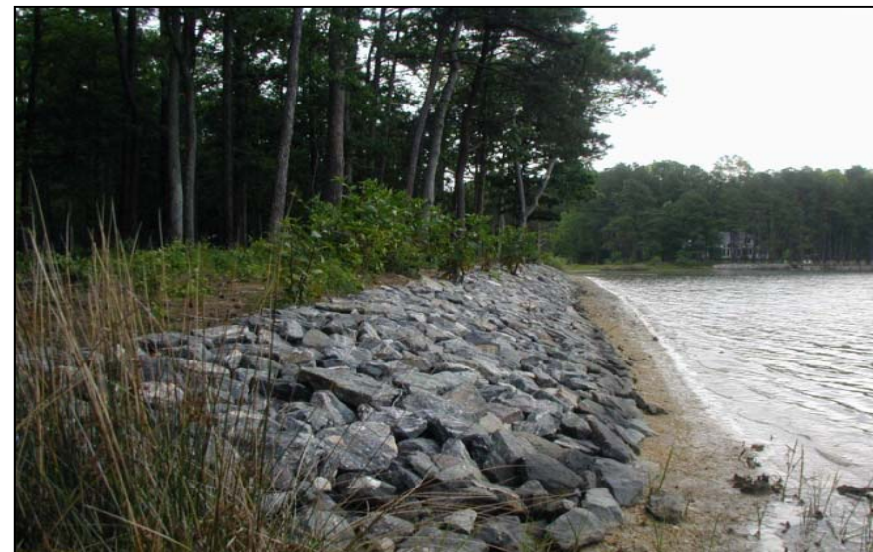
properly sloped with spaces between stones to allow for wave energy dissipation; buried toe (excavated trench) and filter cloth under the stone to distribute weight evenly.

Trench for buried toe

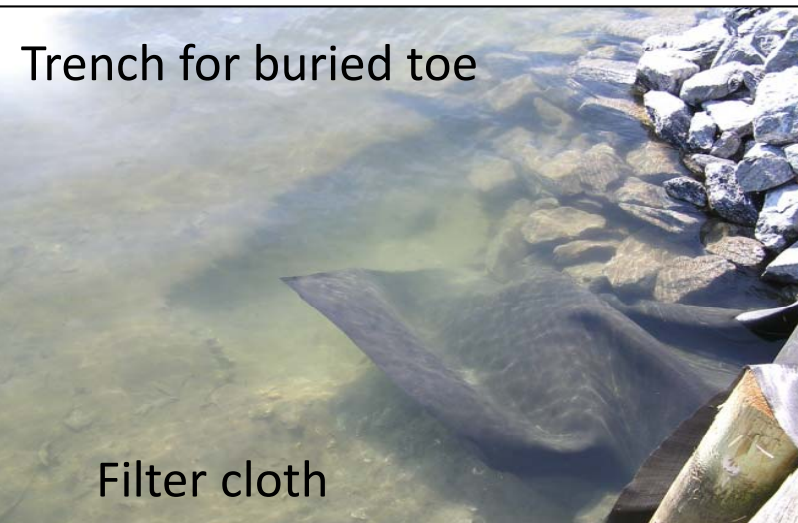
Filter cloth

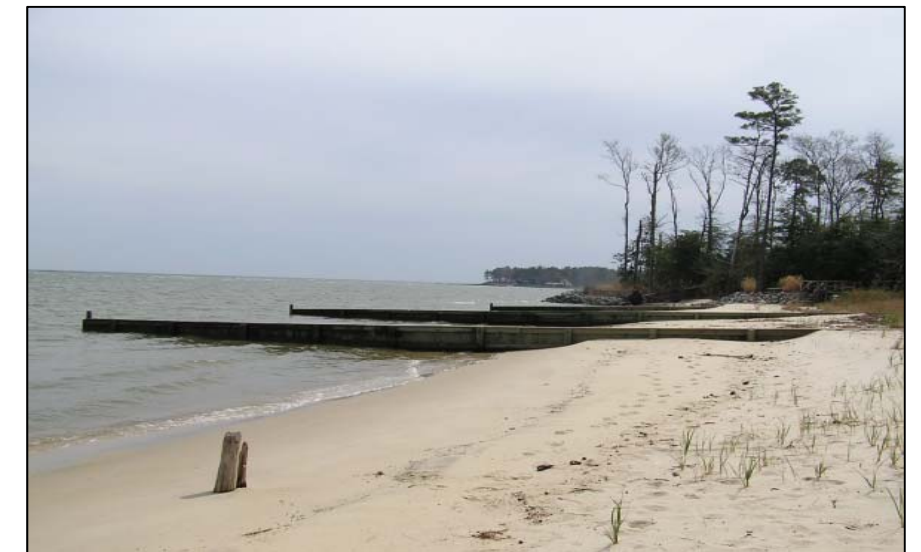
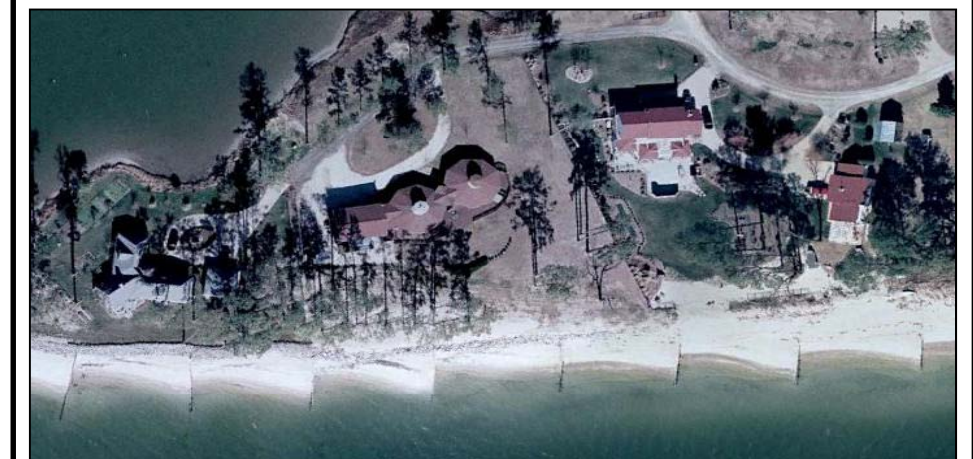
Serviceable Groins

timber or stone intact along entire length; landward ends tie into upland; partial or complete burial under sand indicates they are effective
