Living Shoreline Design Training

What is Success?

Shoreline Studies
Program

March
2021

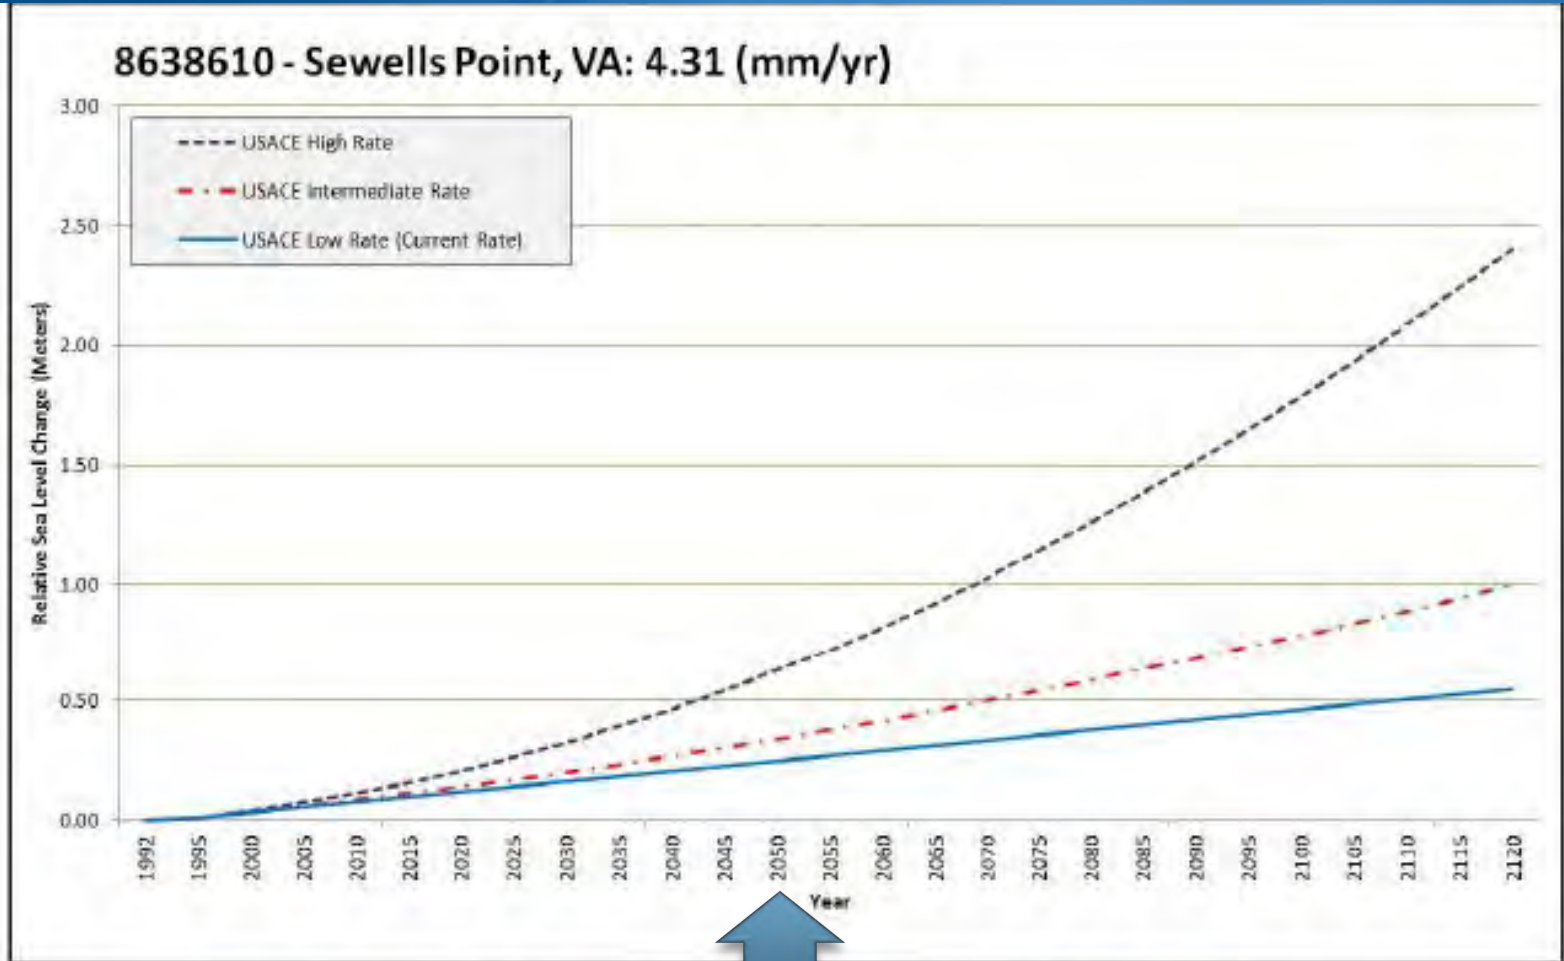
Figure 10: Projected Sea Level Rise at Sewell's Point Station (1992 - 2120)

Sea-level rise predictions from the U.S. Army Corps of Engineers (2014). 2050 : SLR scenarios +1 and +2 feet

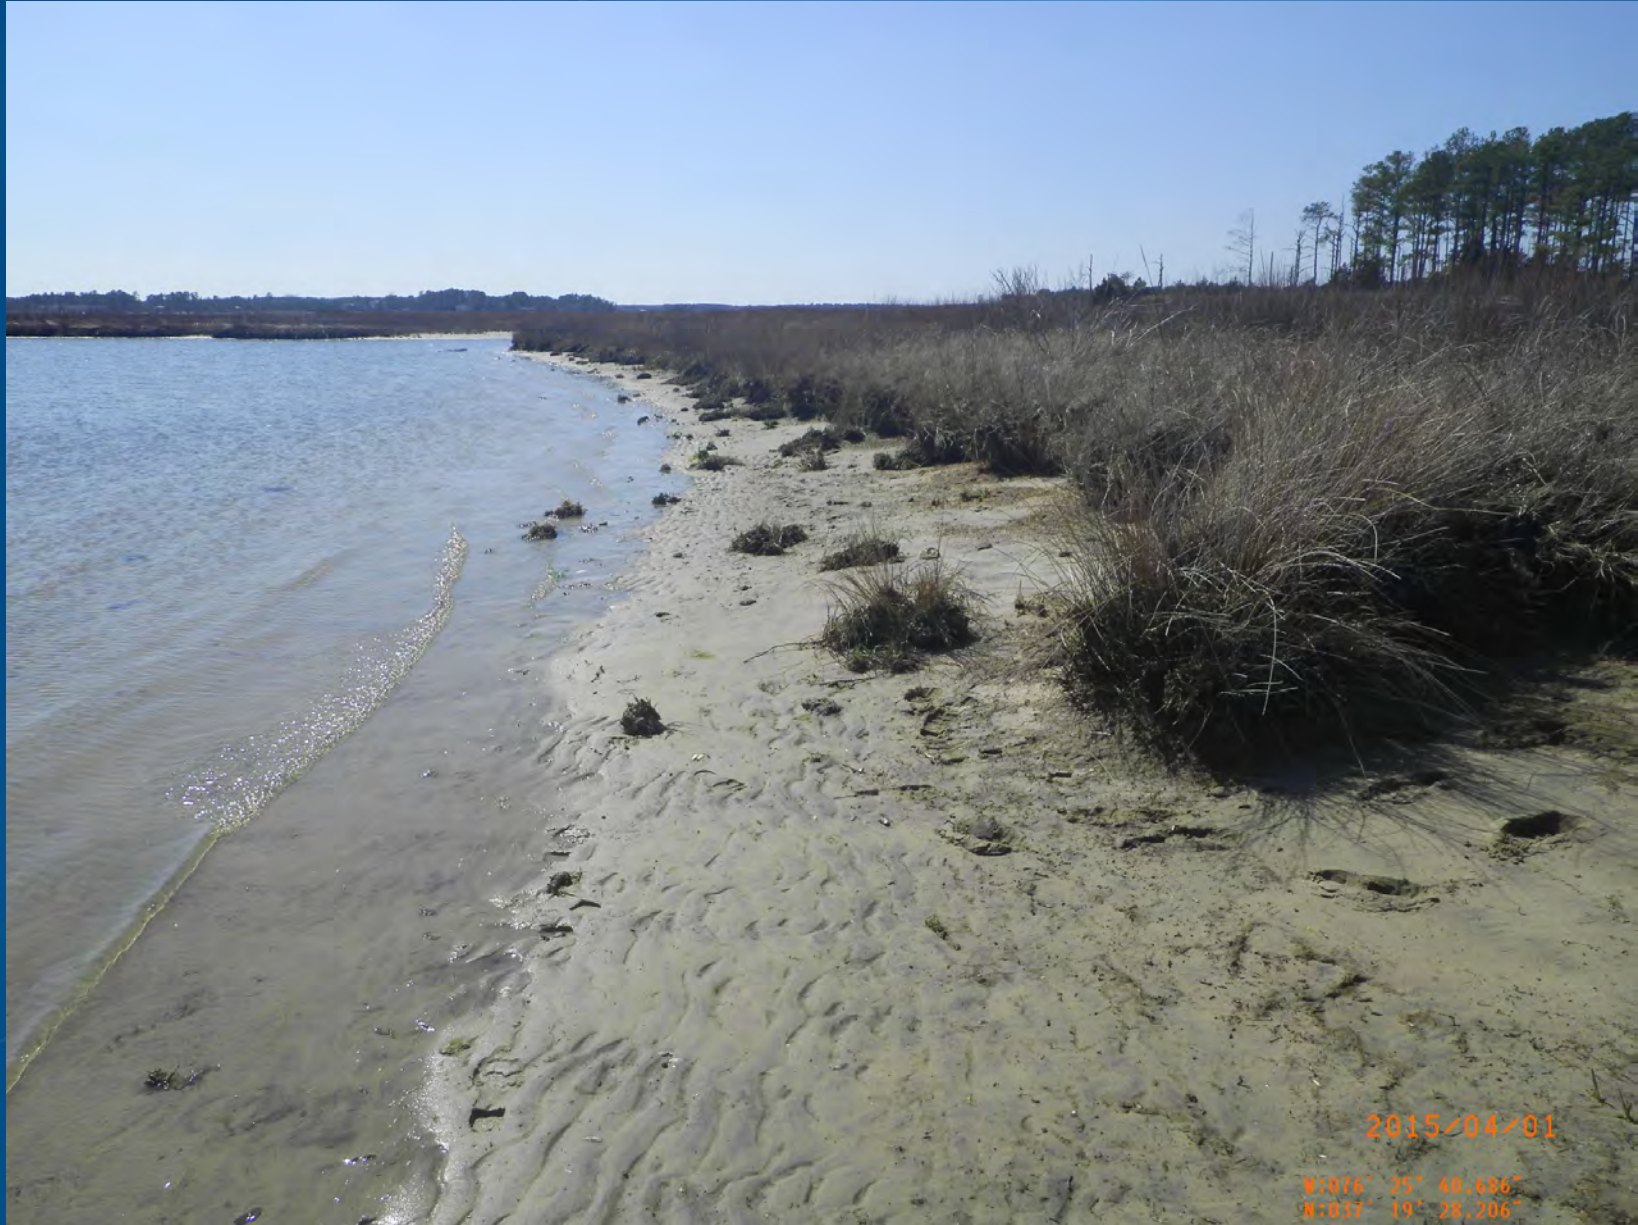
Conditions at Captain Sinclair before the project. Photo: Shoreline Studies Project

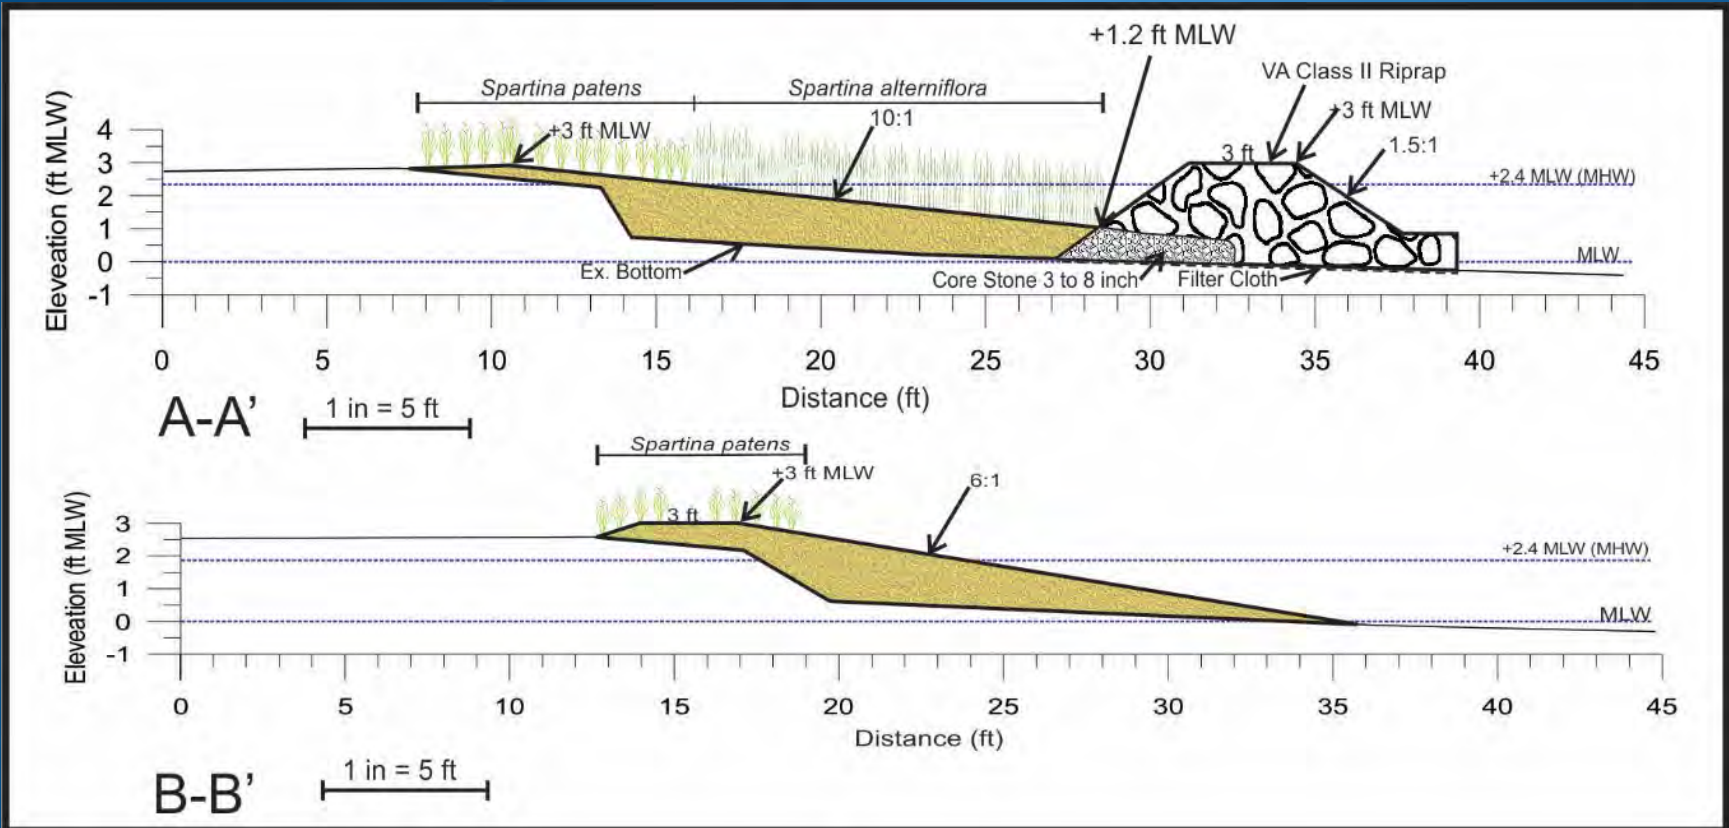
Typical cross-sections for the Captain Sinclair living shoreline project by Shoreline Studies Program, VIMS.

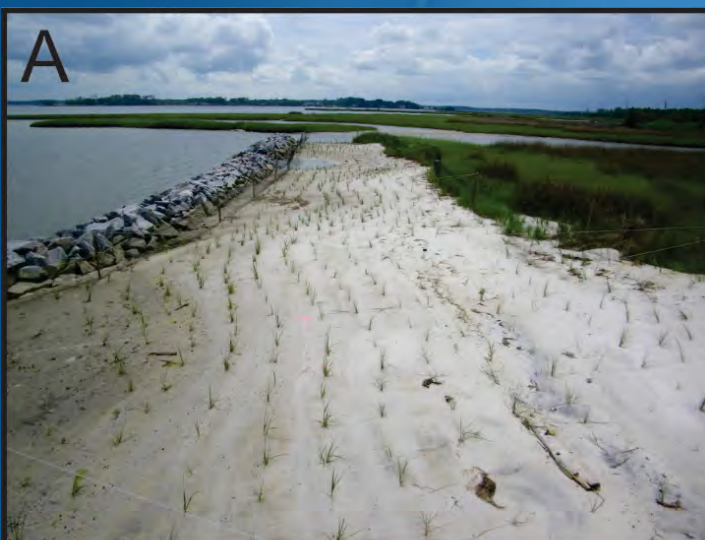
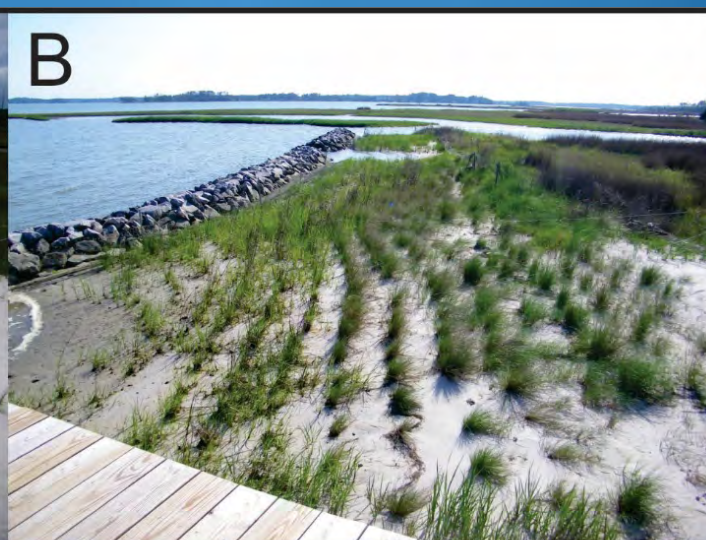
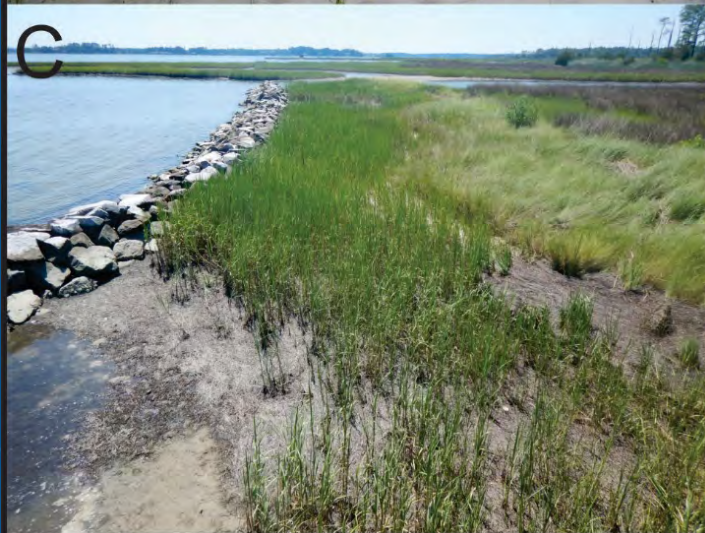
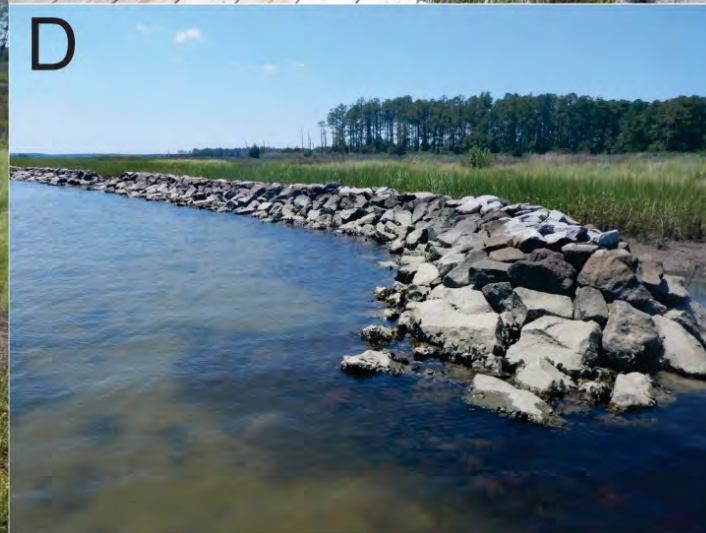
Photos of Captain Sinclair A) Just planted, 2 June 2016; B) One year post planting, 10 May 2017; C) Two years post-planting, 10 July 2018; D) Oysters line the rock sill shown at low water, 10 July 2018. Photo credit: Shoreline Studies Program.

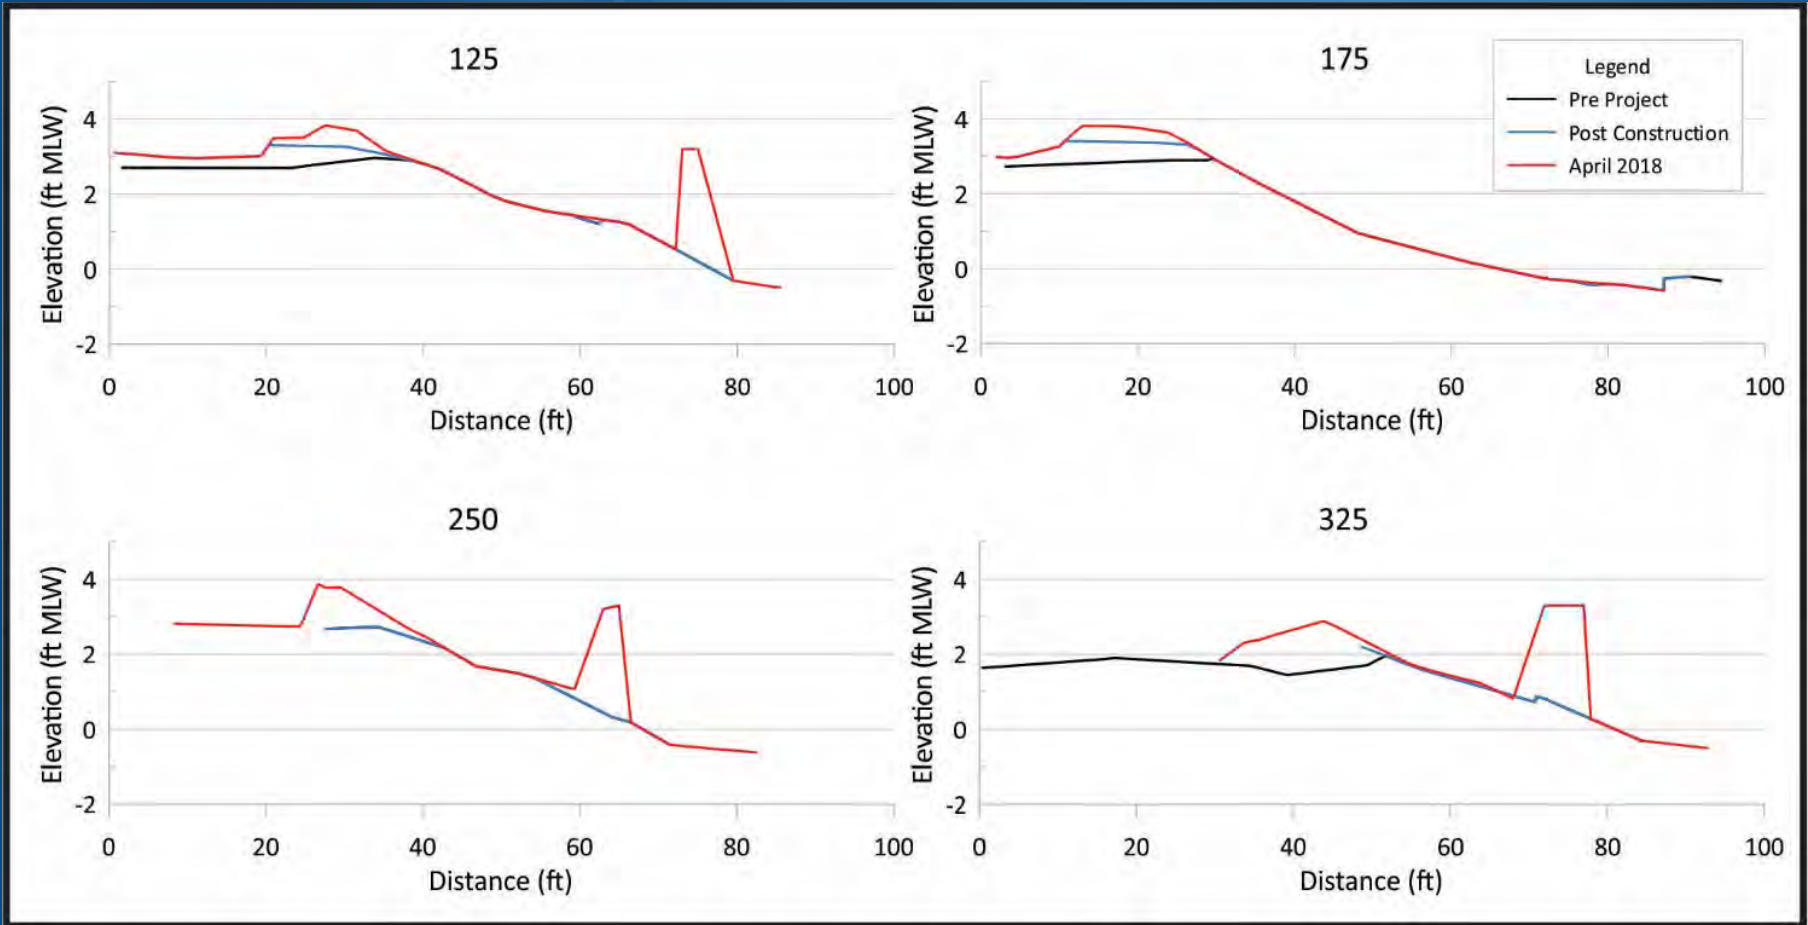
Cross-sections of survey data for Captain Sinclair.

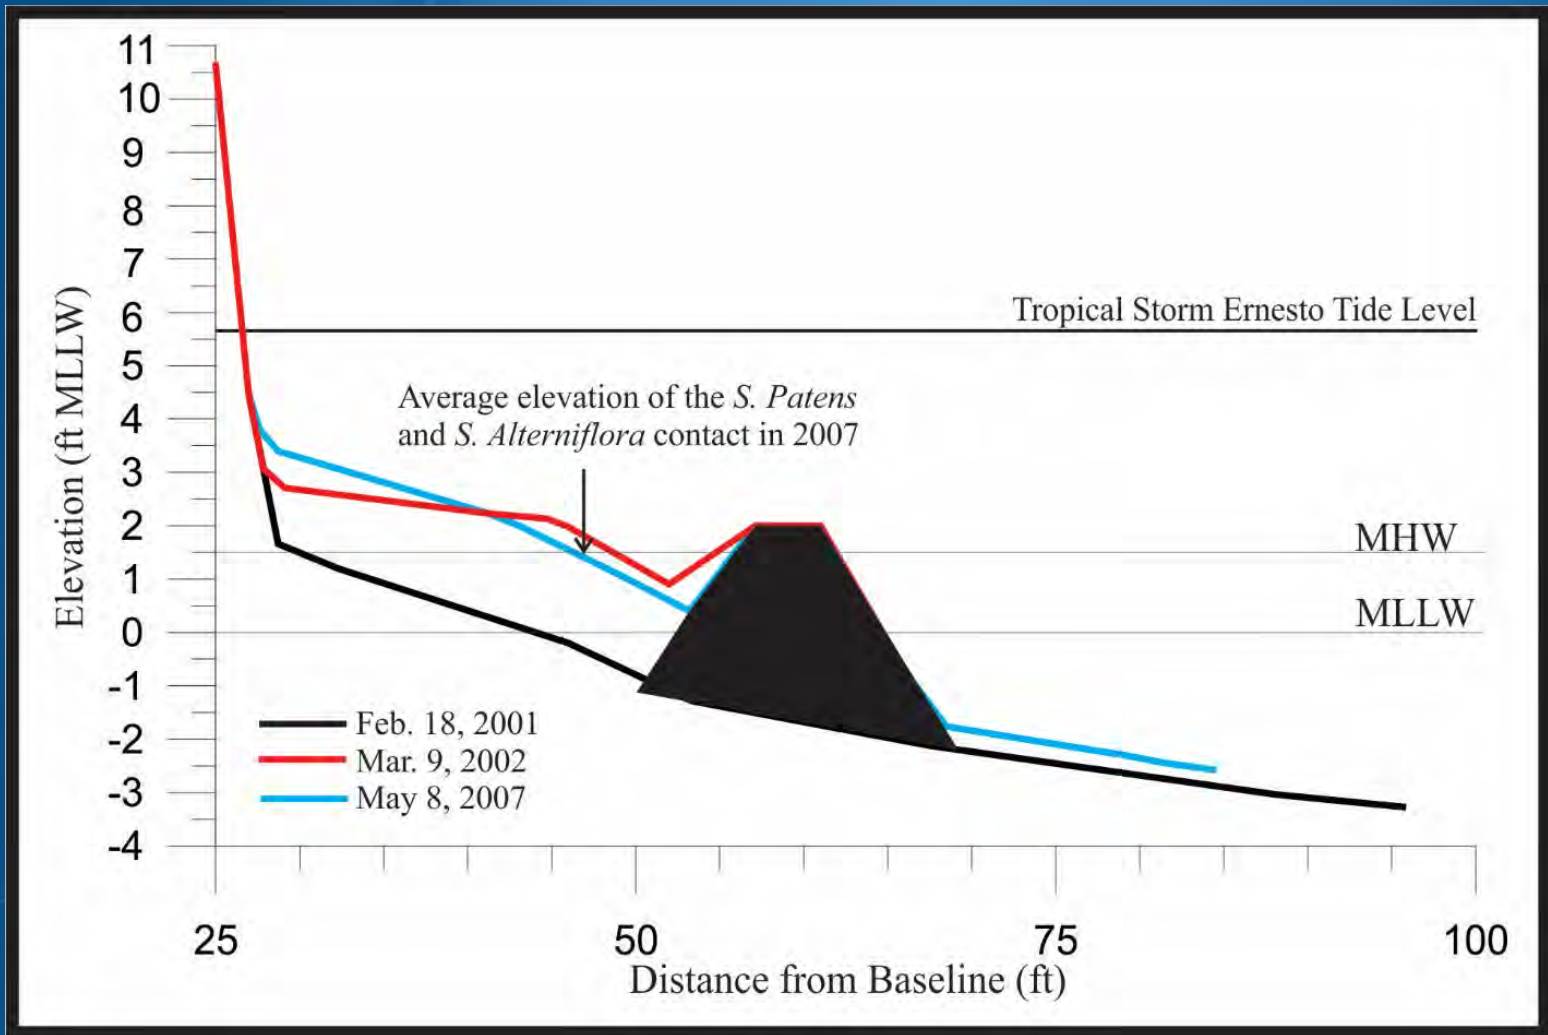
Typical St. Mary's City sill profile from survey data.

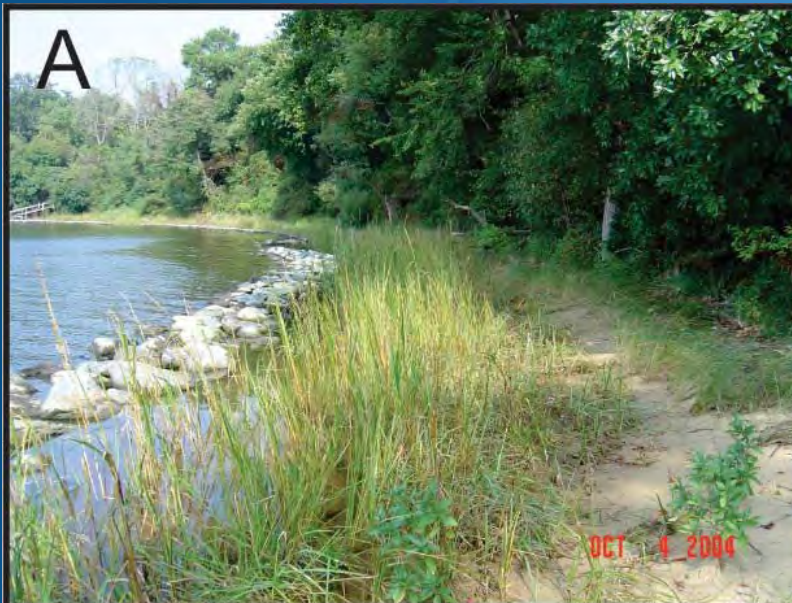
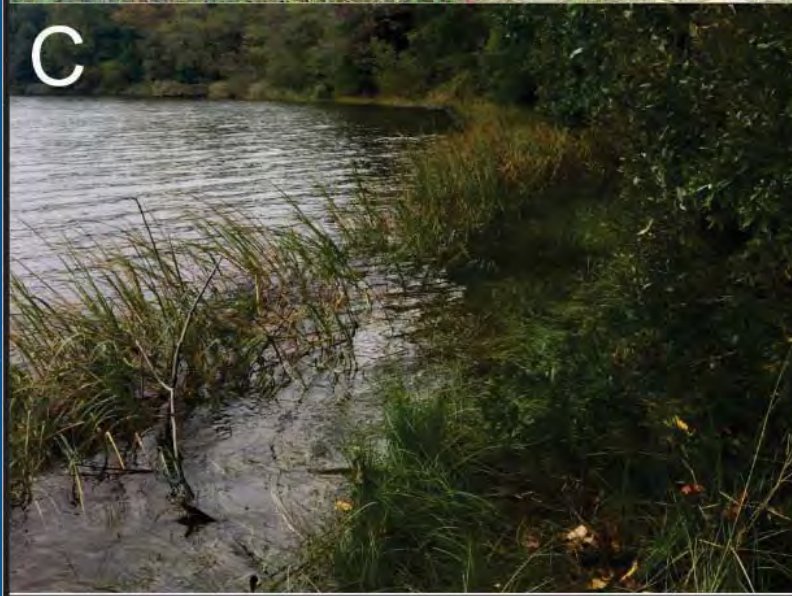
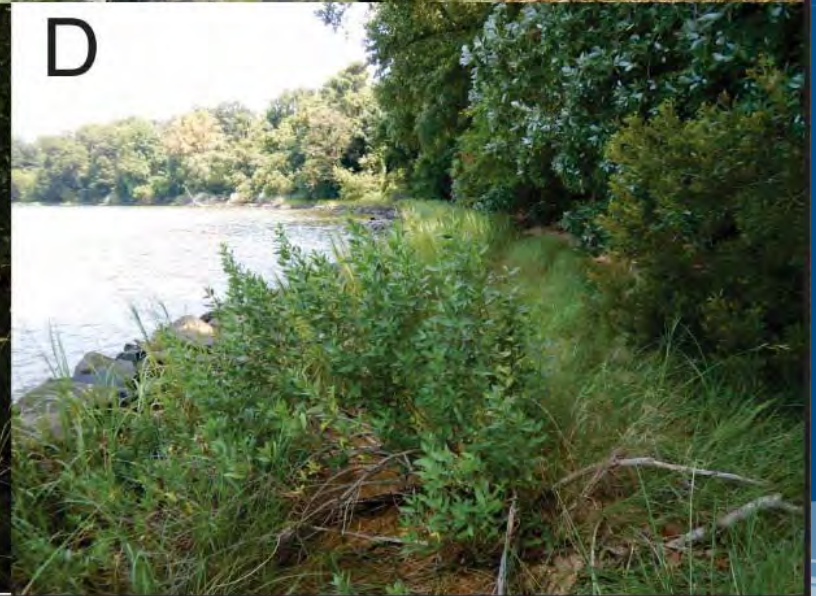
Photos of St. Mary's, South end: **A)** two years after construction (4 Oct 2004), **B)** 11 years after construction (1 Feb 2013), **C)** 15 years after construction (13 Oct 2017), **D)** 16 years after construction (15 Aug 2018).

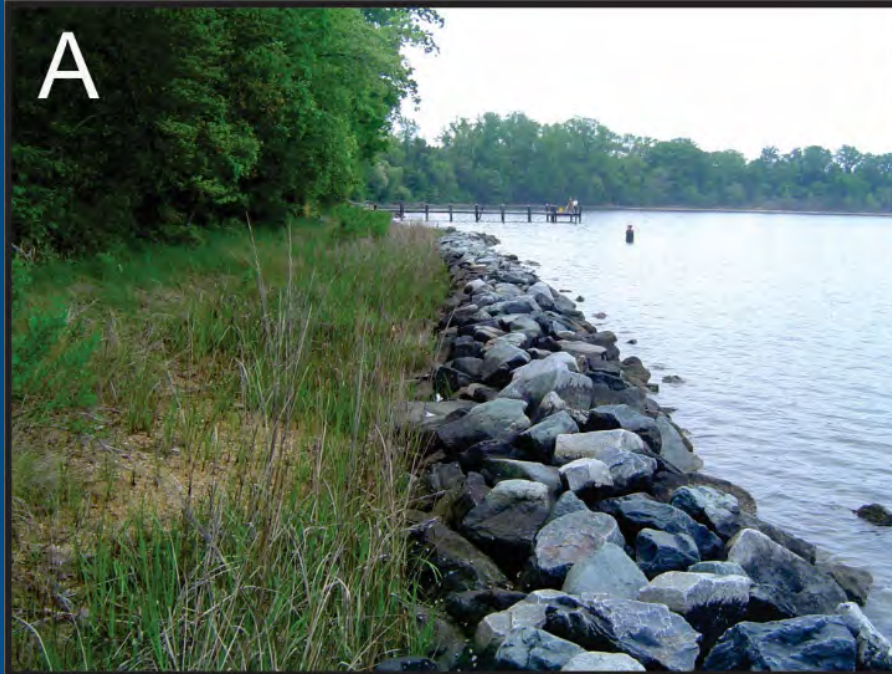
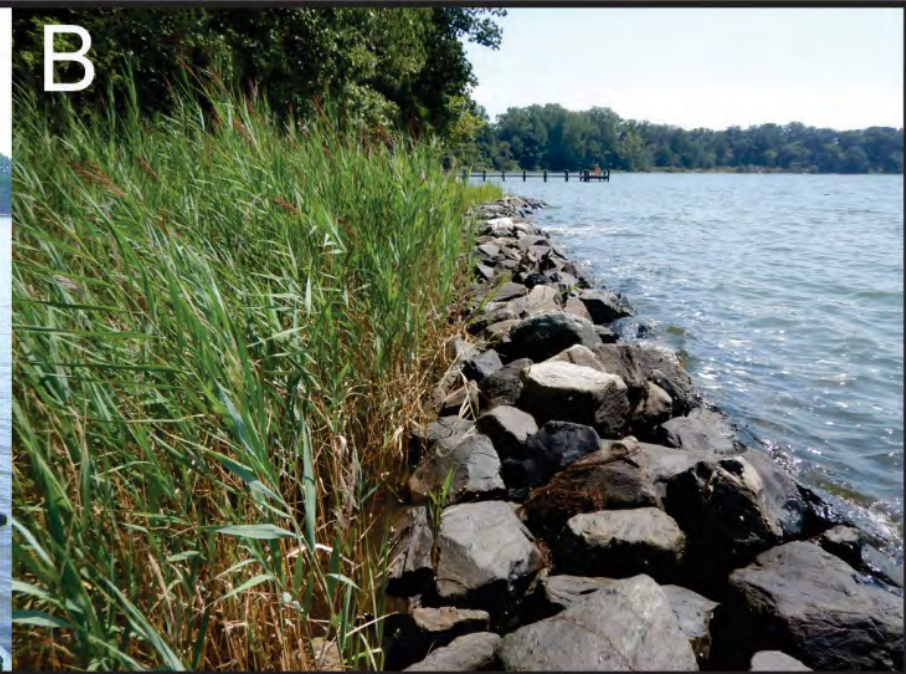
Sill at St. Mary's City A) five years after construction (9 May 2007), B) 16 years after construction (15 Aug 2018). Phragmites has colonized behind the structures.

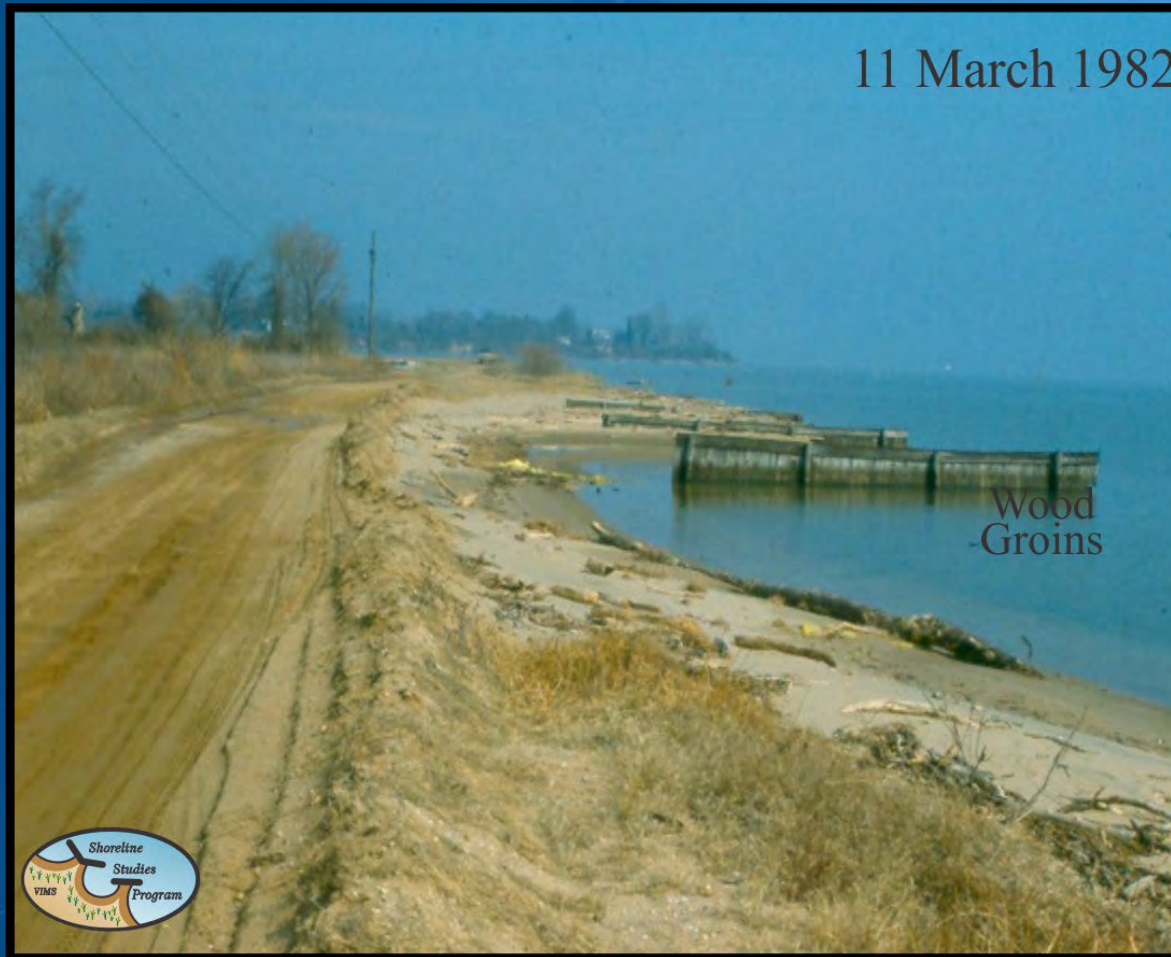
Wood
Groins

Aquia Landing shoreline on 11 March 1982 prior to the breakwater installation.

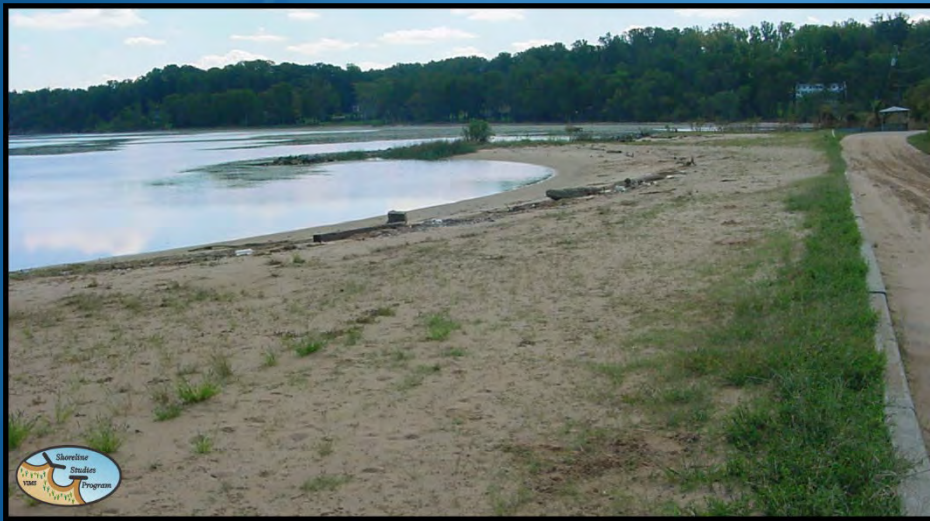
Aqua Landing shoreline on 30 September 2003 post Hurricane Isabel. Though sand washed over the jersey wall, overall the system is intact

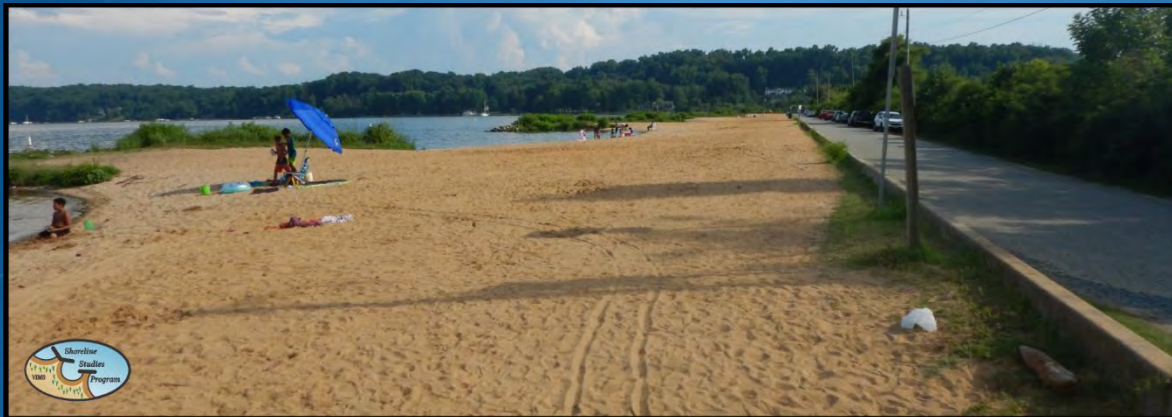
A wide recreational beach exists at Aqua Landing shoreline on 16 Jul 2019.

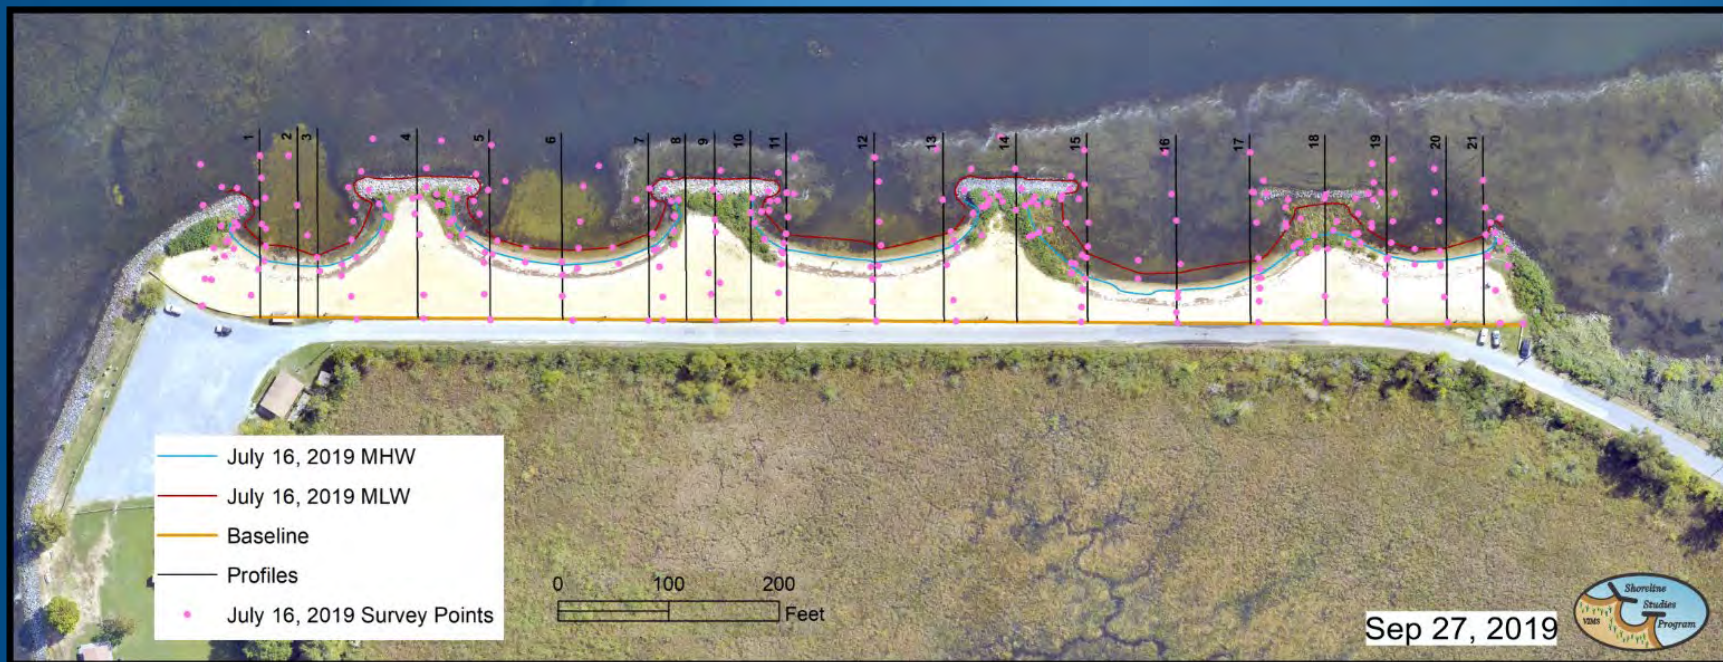
Data points collected to determine elevation changes at the site since installation. Also shown are the measured mean high water and mean low water lines and the cross-sectional profiles exported for the project.

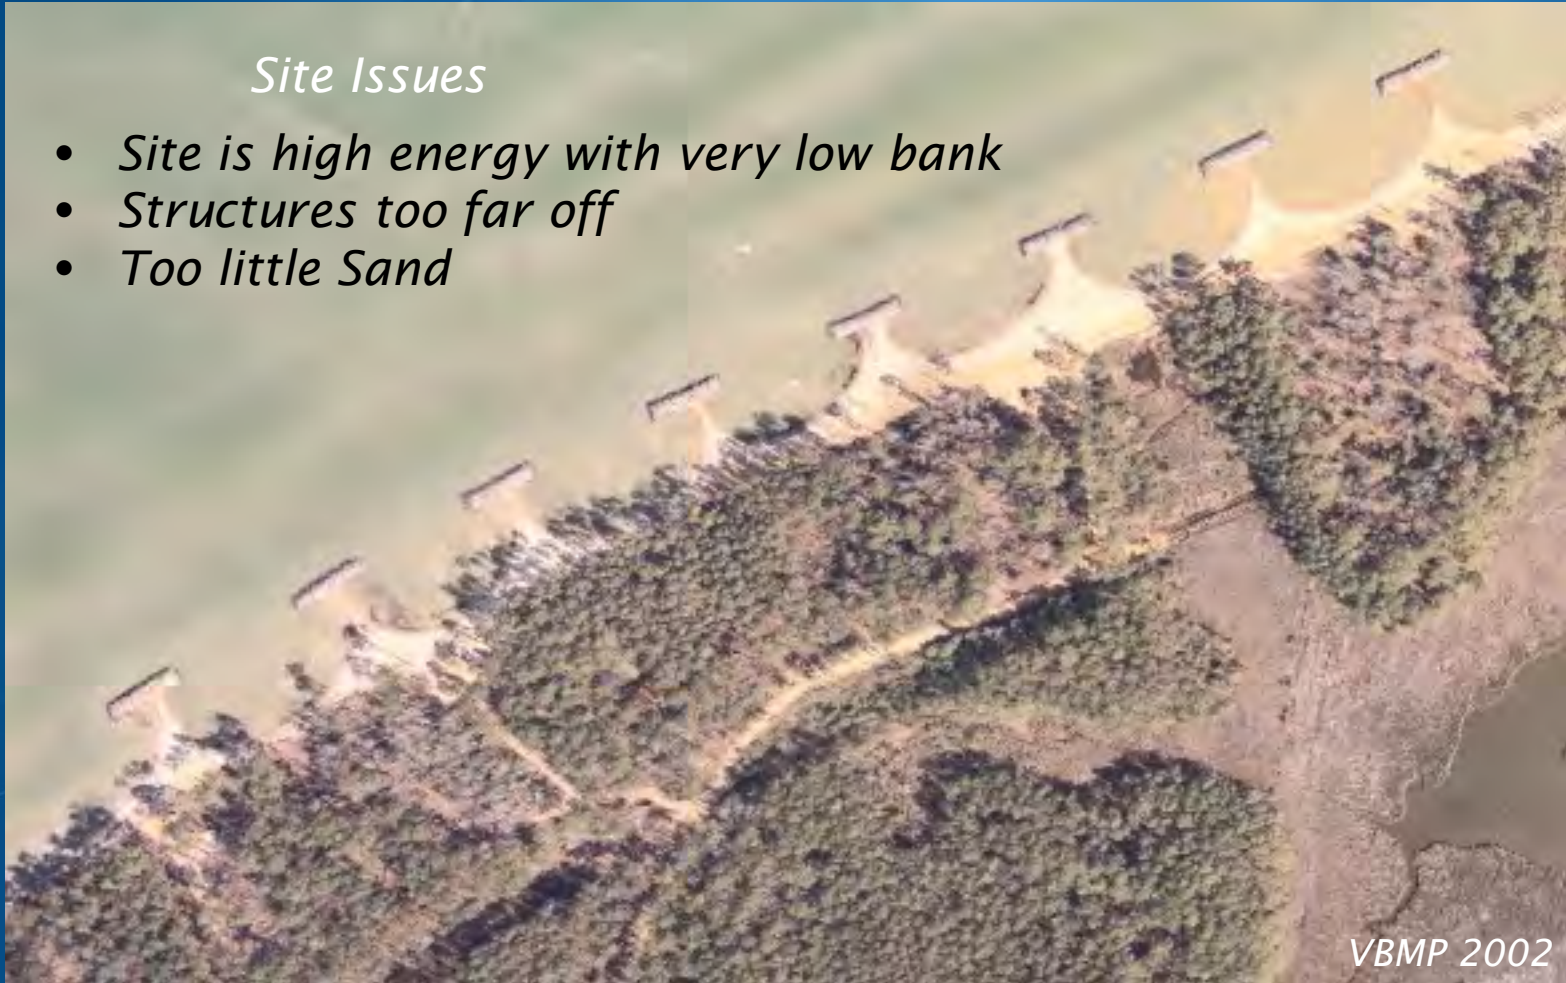
Henry's Island Lancaster County Pre-Isabel 2002

- *Site is high energy with very low bank*
- *Structures too far off*
- *Too little Sand*

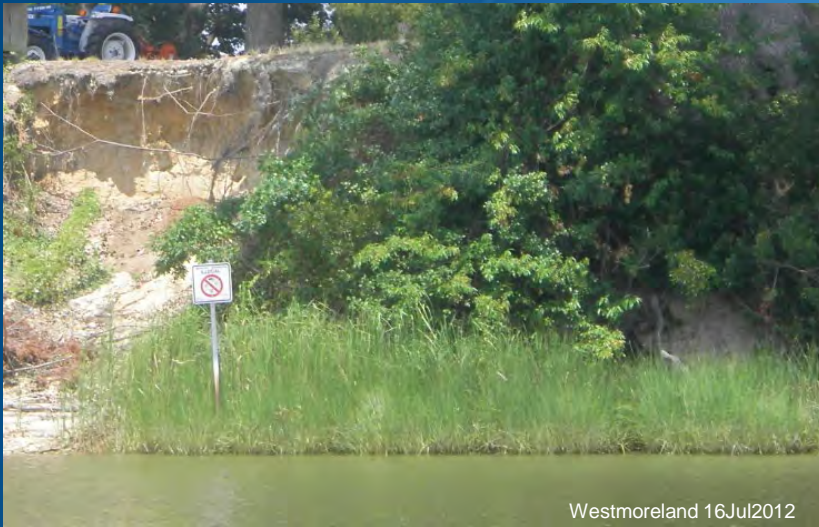
Rising water levels affect living shorelines in several ways:

- Plant populations can be displaced due to the increased duration and extent of flooding and increased salinities.
- The marsh may not be able to migrate inland where high banks occur (coastal squeeze).
- Higher water levels particularly during storms overtop systems reducing the effectiveness of the stone structures to lessen the amount of wave energy impacting the site leading to erosion of the backshore or bank.

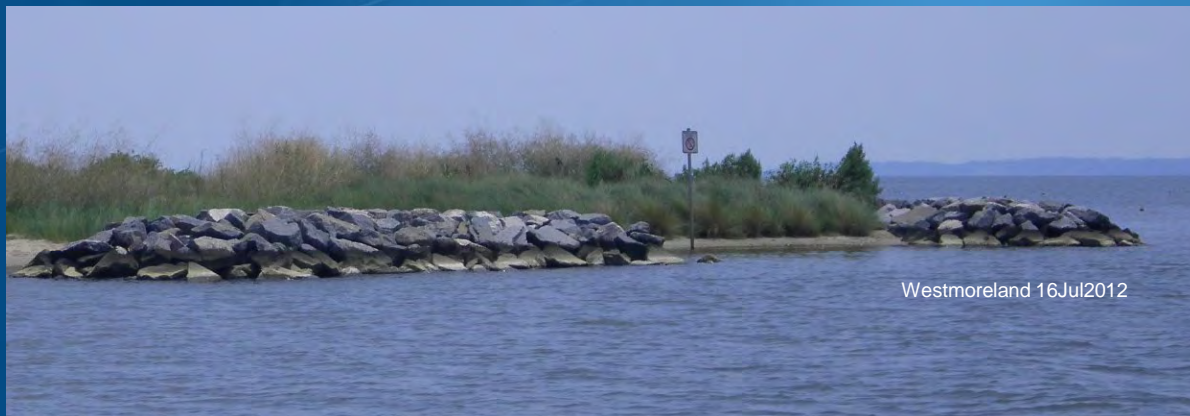
Unpredictable Water Levels: Storm surge and storm waves

- Coastal areas are experiencing more frequent and more intense storms.
- Modeled significant wave heights may not reflect the energy impacting a site during storms.
- To provide a level of protection for the project, balancing the average fetch vs the longest fetch is needed size rock appropriately to maintain the structure during storms.

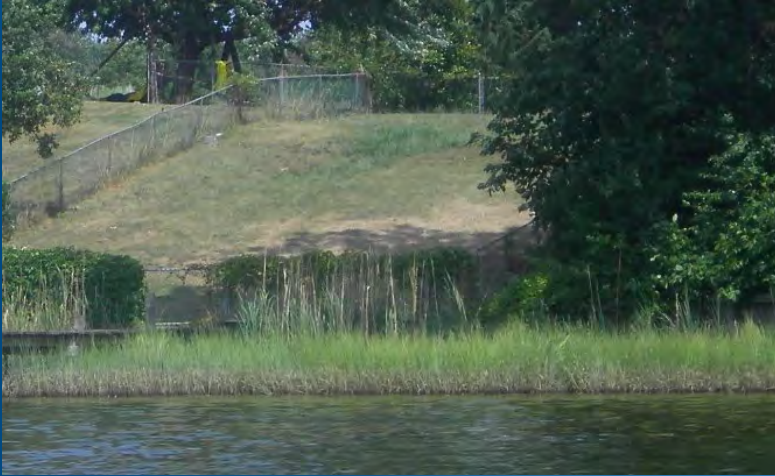
- For a marsh to survive under SLR, habitats migrate from *S. alterniflora* to *S. patens*.
- High banks lead to a coastal squeeze for marsh habitats because the upper marsh is trapped.
- To adapt, banks must be graded or the whole system has to move up.

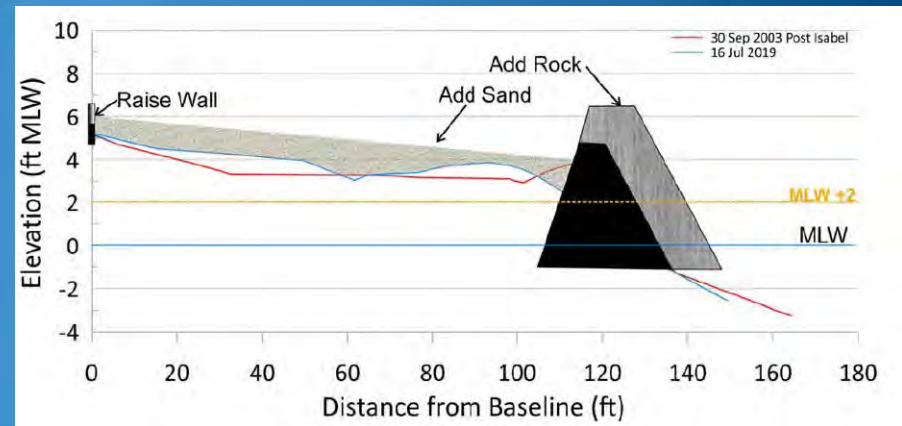
Westmoreland 16Jul2012

- To add rock and sand, armor size has to be sized so you have to raise it to a certain level.
- Should the cost be higher now or wait until it is needed?
- Will there be access to the site when the adaptations need to occur?
- By designing for a higher level of protection (50 yr vs 10 yr), the site can adapt and adjust to SLR better before intervention is needed.
